Killean Wind Farm

Technical Appendix 9.3: Schedule of Watercourse Crossings

SLR Consulting Limited

2.1 Existing Watercourse Crossings

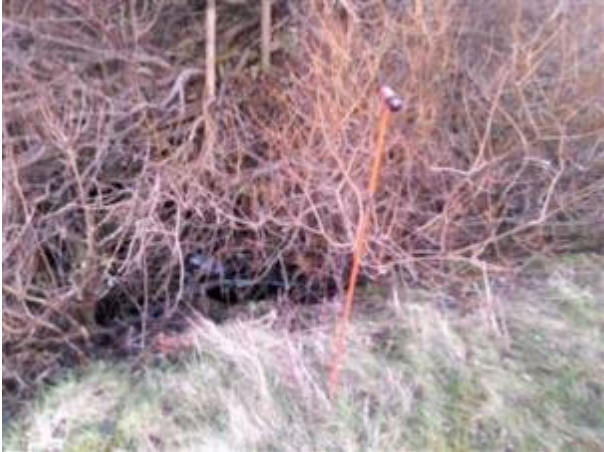
Watercourse Crossing ID	WX01
Watercourse Crossing Details	<p>Grid Reference: E 170074 / N 644889</p> <p>Status: Existing</p> <p>Culvert Diameter: 1m high 0.5m wide (downstream)</p> <p>Culvert Construction Type: Stone culvert (downstream)</p> <p>Watercourse Width: 0.5m (downstream)</p> <p>Watercourse Depth: 0.1m (downstream)</p> <p>Notes: Entrance of the culvert was obscured by branches. It is assumed that the culvert extends approximately 100m under the field to the south-west of the crossing and diverts water to the Killean Burn. Plastic water pipe (presumed to be PWS pipework) is noted near culvert entrance.</p>
Photograph Looking at Culvert Entrance from Upstream

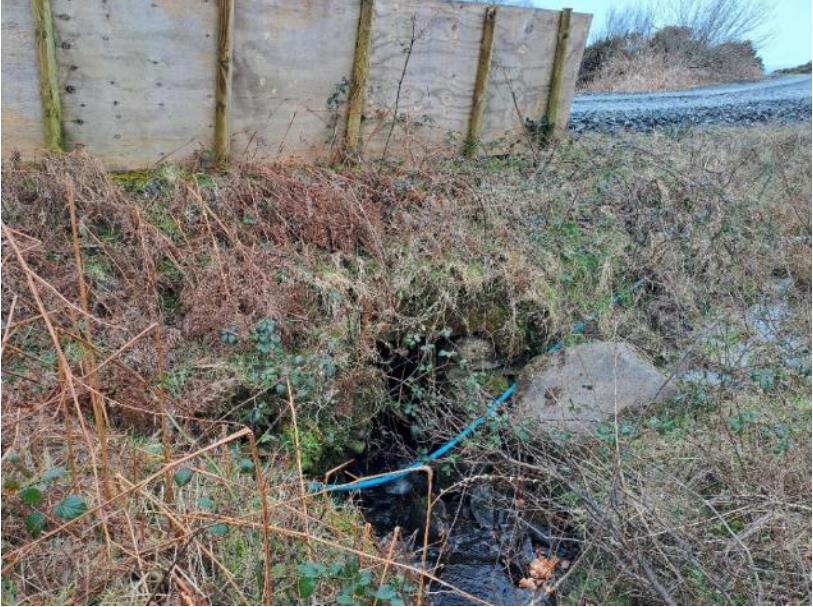
Watercourse Crossing ID	WX02
<p>Watercourse Crossing Details</p>	<p>Grid Reference: E 170458 / N 644818 Status: Existing Culvert Diameter: 1.2m Culvert Construction Type: Stone culvert Watercourse Width: 1.2m Watercourse Depth: 0.3m Notes: Plastic water pipe (presumed to be PWS pipework) is noted near culvert entrance.</p>
<p>Photograph Looking at Culvert Entrance from Upstream</p>

<p>A photograph showing the upstream view of a culvert entrance. The entrance is a dark opening in a concrete wall, partially obscured by a dense thicket of dry, brown brush and some green plants. A blue plastic pipe is visible near the entrance. The background shows a concrete wall and a clear sky.</p>
<p>Photograph Looking at Culvert Exit from Downstream</p>

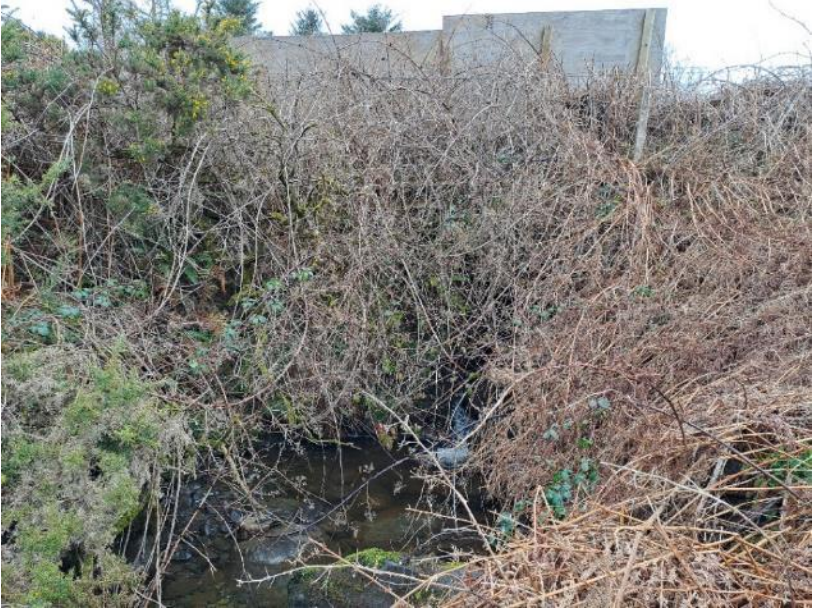
<p>A photograph showing the downstream view of a culvert exit. The exit is a dark opening in a concrete wall, heavily obscured by a dense thicket of dry, brown brush and some green plants. The background shows a concrete wall and a clear sky.</p>

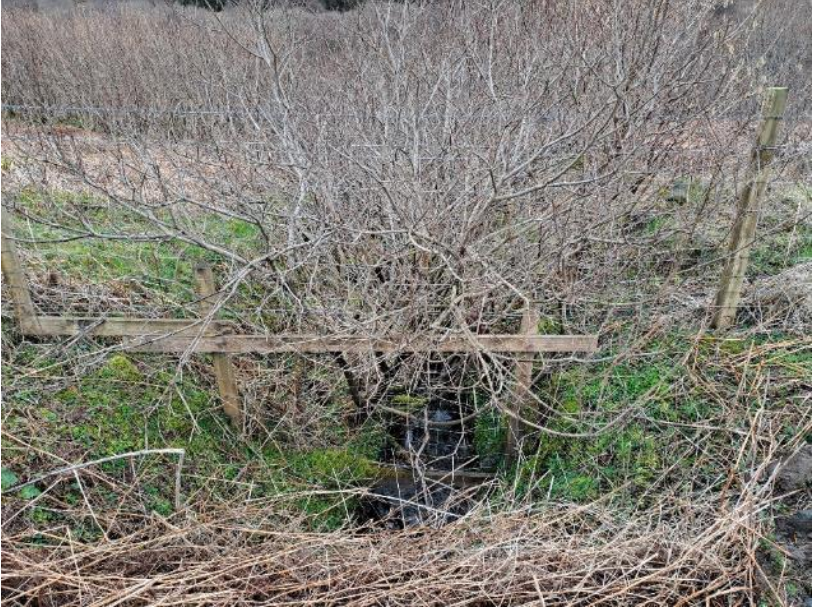
Watercourse Crossing ID	WX03
Watercourse Crossing Details	<p>Grid Reference: E 171157 / N 644686</p> <p>Status: Existing</p> <p>Culvert Diameter: 0.7m</p> <p>Culvert Construction Type: Concrete circular culvert</p> <p>Watercourse Width: 0.7m</p> <p>Watercourse Depth: 0.2m</p> <p>Notes: Heavily vegetated, difficult to access. Another culvert is noted approximately 15m upstream of the crossing point.</p>
Photograph Looking at Culvert Entrance from Upstream

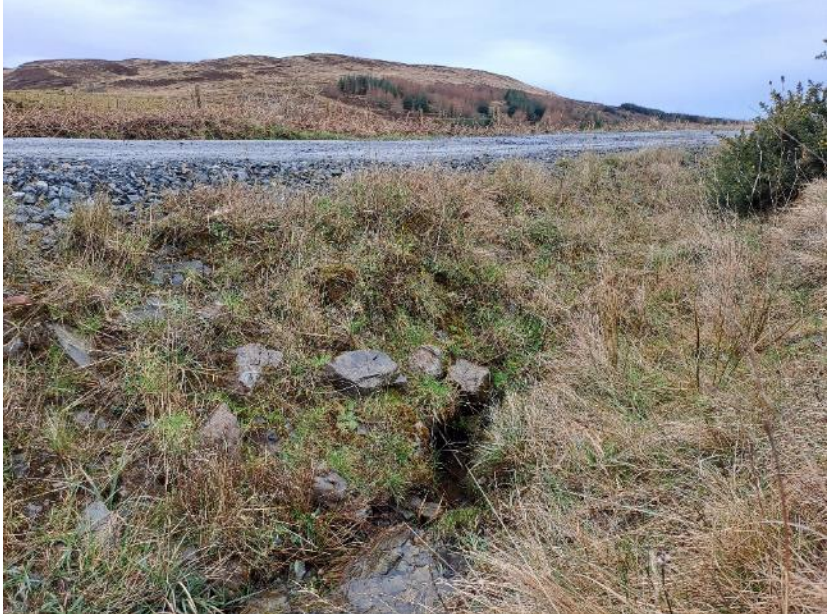
Watercourse Crossing ID	WX05
<p>Watercourse Crossing Details</p>	<p>Grid Reference: E 171506 / N 644740 Status: Existing Culvert Diameter: 0.3m Culvert Construction Type: Circular culvert Watercourse Width: 0.5m Watercourse Depth: 0.1m Notes: Water upstream of the crossing is fed by track drainage and runs to the north of the track, east of the crossing.</p>
<p>Photograph Looking at Culvert Entrance from Upstream</p>

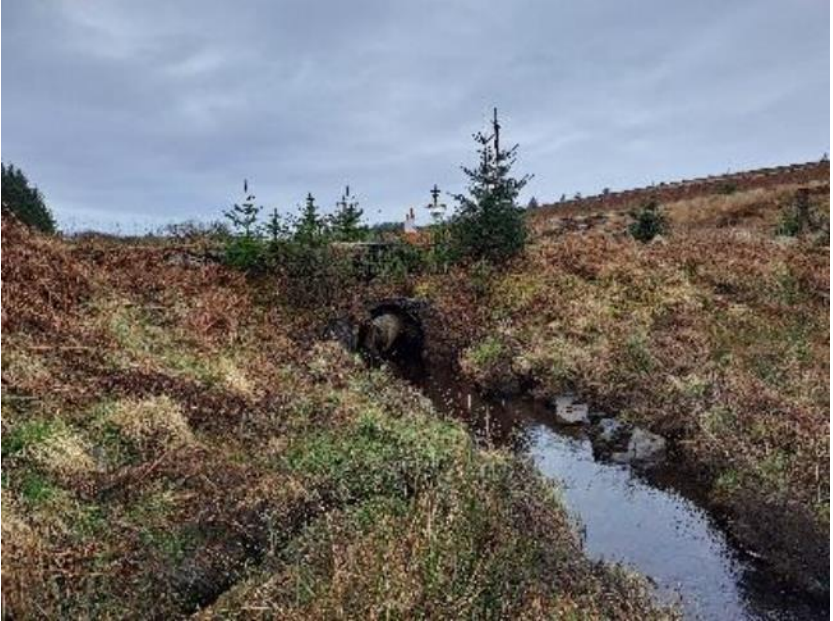
Watercourse Crossing ID	WX07
Watercourse Crossing Details	<p>Grid Reference: E 172008 / N 645227</p> <p>Status: Existing</p> <p>Culvert Diameter: 1m</p> <p>Culvert Construction Type: Corrugated metal circular culvert reinforced with stone.</p> <p>Watercourse Width: 1.5m</p> <p>Watercourse Depth: 0.3m</p> <p>Notes: None.</p>
Photograph Looking at Culvert Entrance from Upstream

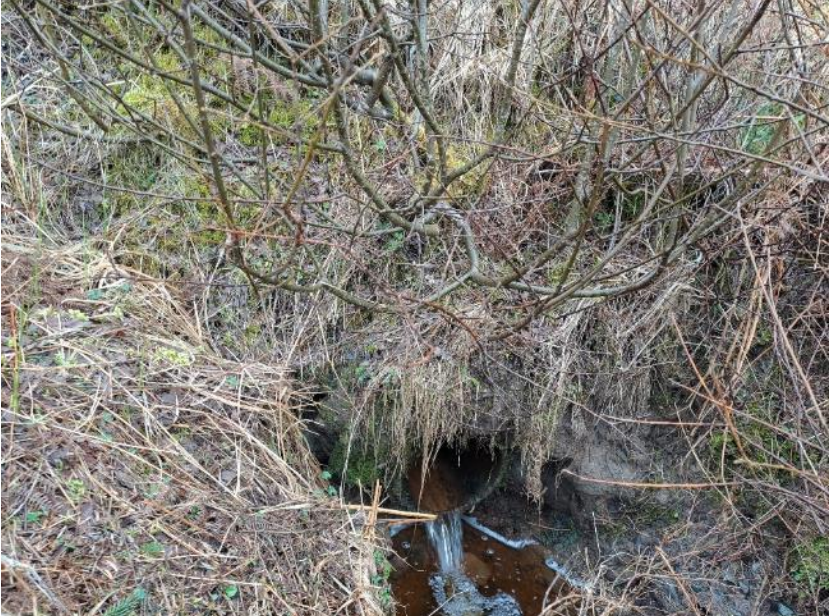
Watercourse Crossing ID	WX08
Watercourse Crossing Details	<p>Grid Reference: E 172034 / N 645226</p> <p>Status: Existing</p> <p>Culvert Diameter: 0.3m</p> <p>Culvert Construction Type: Concrete circular culvert</p> <p>Watercourse Width: 0.4m</p> <p>Watercourse Depth: 0.2m</p> <p>Notes: Culvert entrance heavily vegetated.</p>
Photograph Looking at Culvert Entrance from Upstream

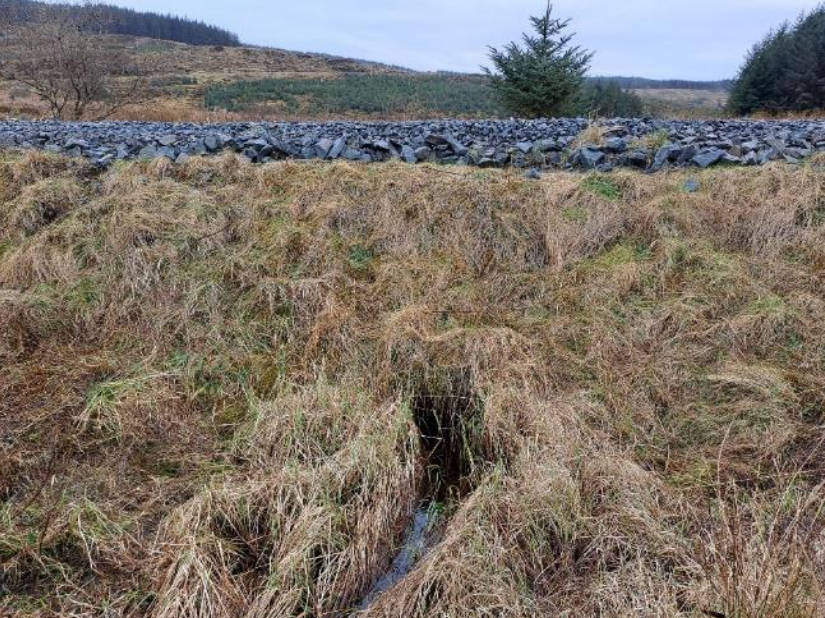
Watercourse Crossing ID	WX09
<p>Watercourse Crossing Details</p>	<p>Grid Reference: E 172133 / N 645336 Status: Existing Culvert Diameter: 0.3m Culvert Construction Type: Concrete circular culvert Watercourse Width: 0.3m Watercourse Depth: 0.1m Notes: Immediately downstream of crossing, watercourse channel is less defined.</p>
<p>Photograph Looking at Culvert Entrance from Upstream</p>

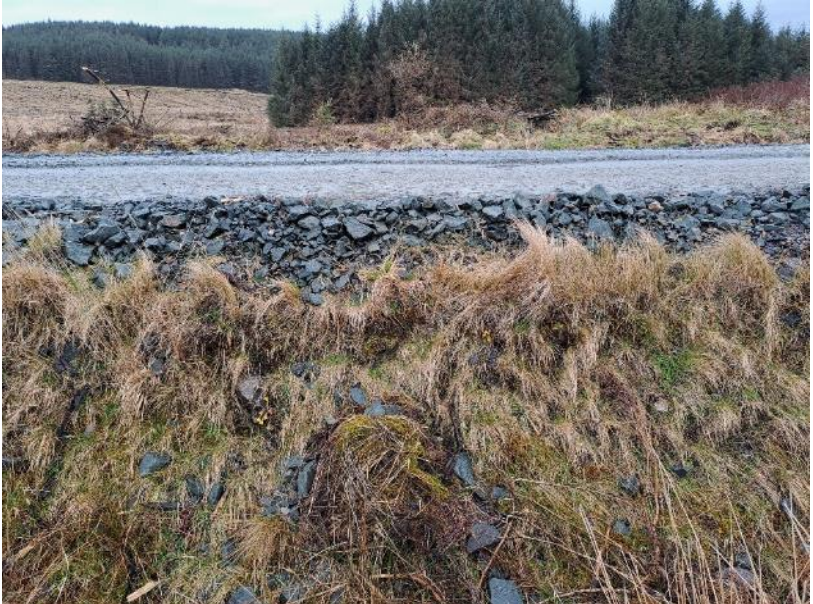
Watercourse Crossing ID	WX10
<p>Watercourse Crossing Details</p>	<p>Grid Reference: E 172216 / N 645377 Status: Existing Culvert Diameter: N/A Culvert Construction Type: N/A Watercourse Width: N/A Watercourse Depth: N/A Notes: Watercourse crossing shown on OS mapping but no culvert is present at this location. Channels are noted either side of the track which collect track drainage and flow to other crossing points along the track.</p>
<p>Photograph Looking at North towards Track</p>

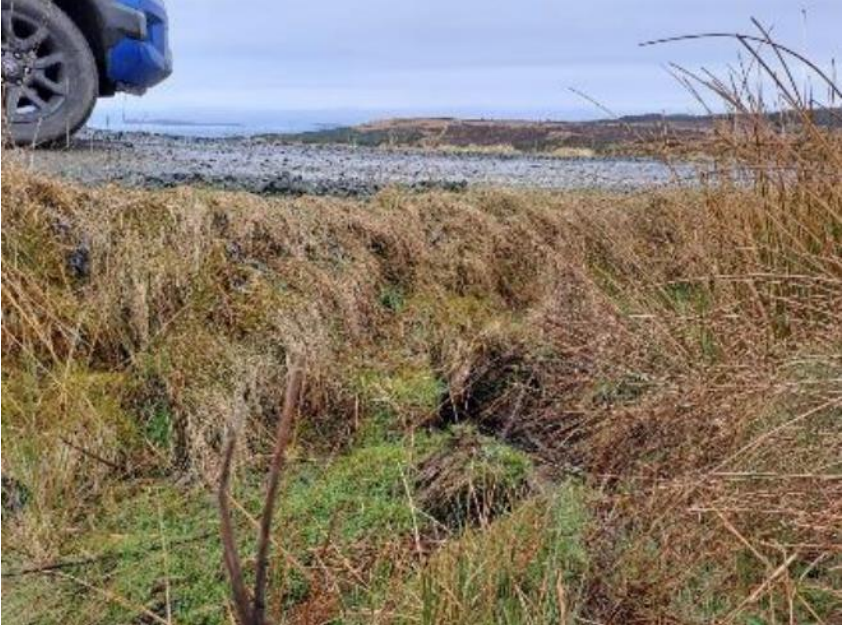
Watercourse Crossing ID	WX12
Watercourse Crossing Details	<p>Grid Reference: E 172655 / N 644747</p> <p>Status: Existing</p> <p>Culvert Diameter: 0.3m</p> <p>Culvert Construction Type: Concrete circular pipe</p> <p>Watercourse Width: 0.3 to 1m</p> <p>Watercourse Depth: 0.2m</p> <p>Notes: Watercourse narrower upstream of crossing compared to downstream.</p>
Photograph Looking at Culvert Entrance from Upstream

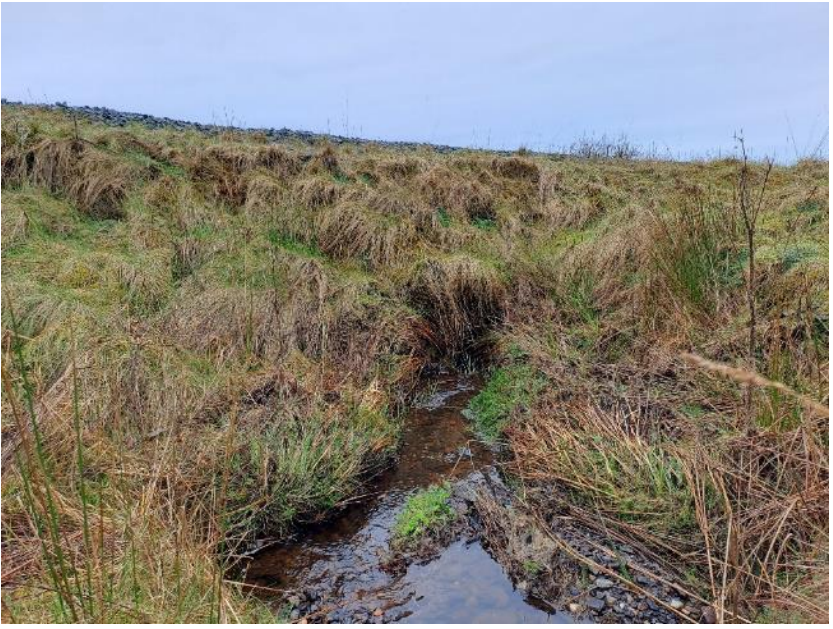
Watercourse Crossing ID	WX13
<p>Watercourse Crossing Details</p>	<p>Grid Reference: E 172767 / N 644623 Status: Existing Culvert Diameter: 0.3m Culvert Construction Type: Concrete circular culvert Watercourse Width: 0.5m Watercourse Depth: 0.2m Notes: None.</p>
<p>Photograph Looking at Culvert Entrance from Upstream</p>

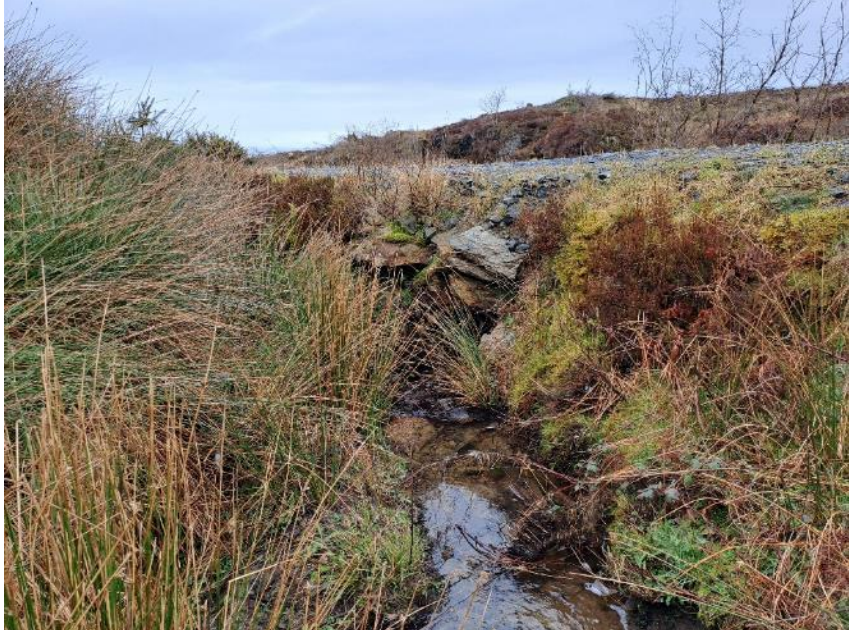
Watercourse Crossing ID	WX14
Watercourse Crossing Details	<p>Grid Reference: E 172518 / N 644835</p> <p>Status: Existing</p> <p>Culvert Diameter: 0.5m</p> <p>Culvert Construction Type: Plastic circular culvert reinforced with stone.</p> <p>Watercourse Width: 1m</p> <p>Watercourse Depth: 0.3m</p> <p>Notes: None.</p>
Photograph Looking at Culvert Entrance from Upstream

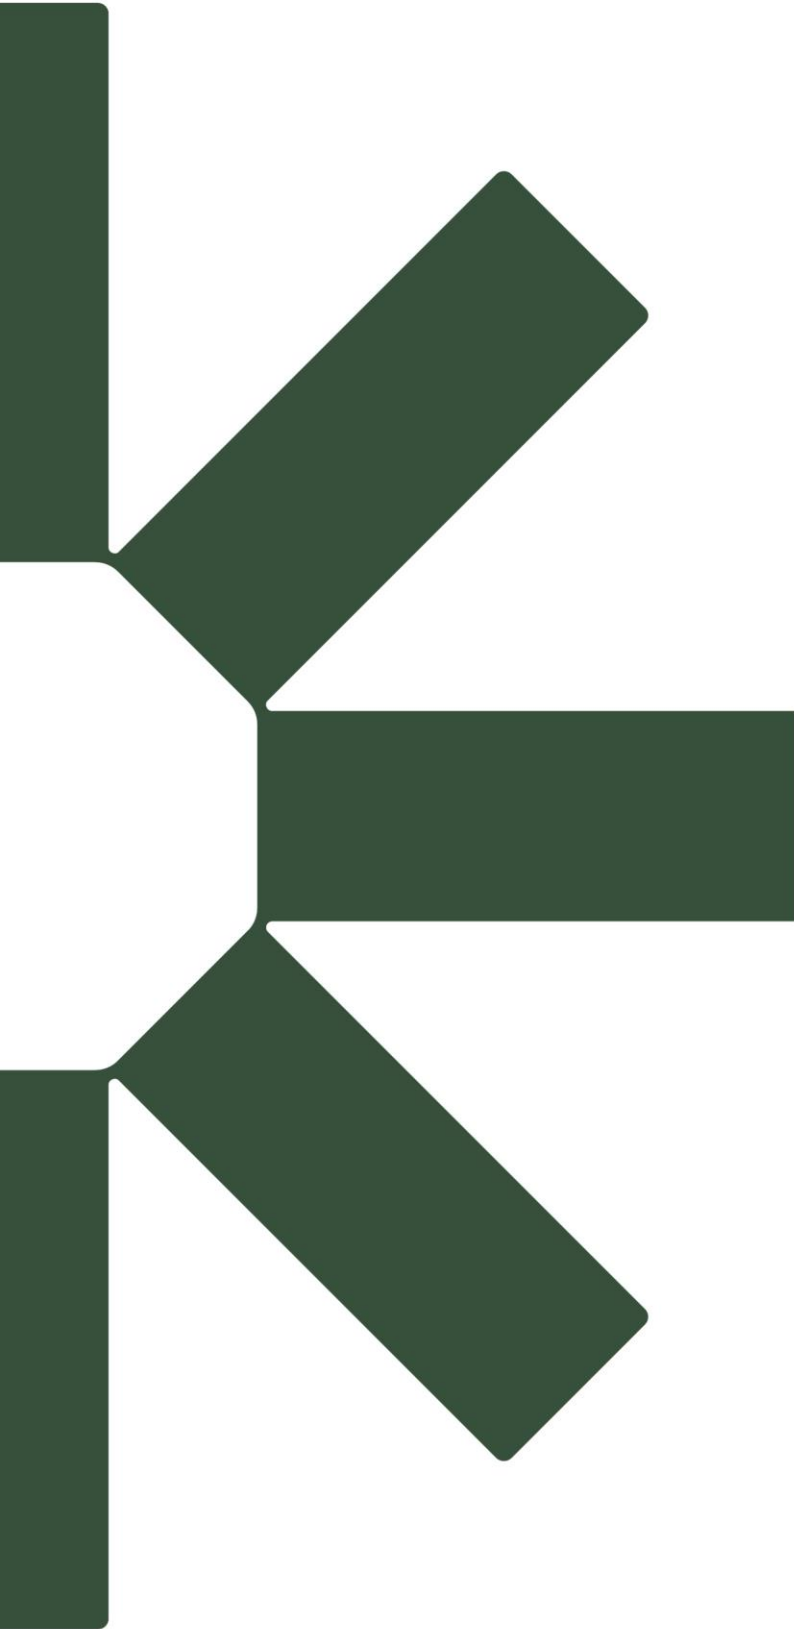
Watercourse Crossing ID	WX16
Watercourse Crossing Details	<p>Grid Reference: E 172140 / N 644091</p> <p>Status: New</p> <p>Watercourse Width: 1m</p> <p>Watercourse Depth: 0.2m</p> <p>Notes: Located within a wider channel approximately 1.5m deep. Boulders noted within the channel bed.</p>
Photograph Looking Upstream	 
Photograph Looking Downstream	 
Potential Crossing Type Likely Required CAR Authorisation	Culvert Registration
